**U.S. Environmental Protection Agency
Pollution Report**

Subject: Pollution Report (Initial) #1
Cornell-Dubilier Site
Site ID #: GZ
Location of Site: 333 Hamilton Boulevard
Middlesex County, South Plainfield, New Jersey

Date: October 21, 2008

Reporting Period: 07:00 Hrs 10/13/08 to 17:30 Hrs 10/20/08

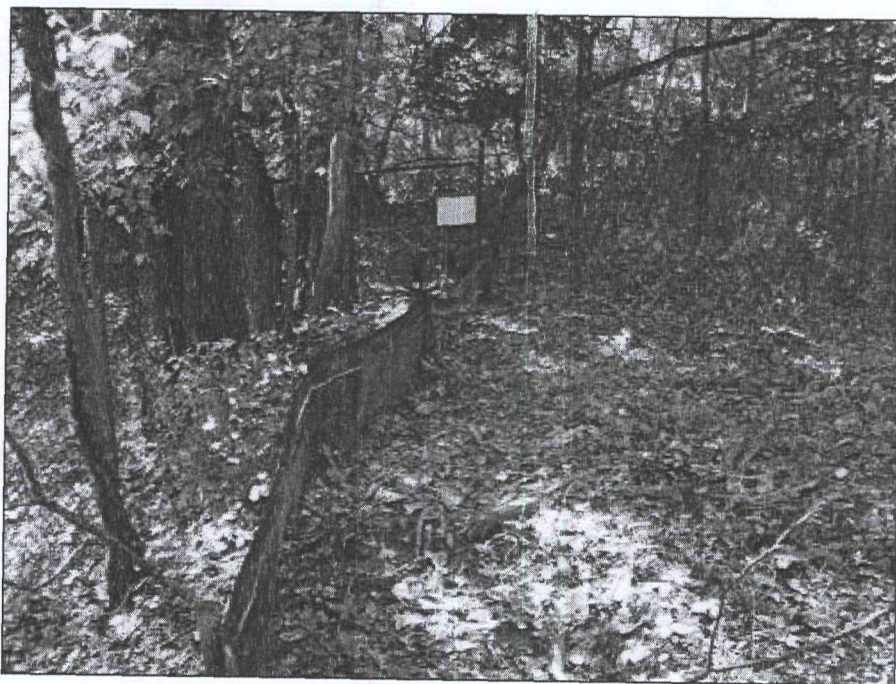
Picture 1: South-eastern corner of Site prior to grubbing (October 14, 2008)

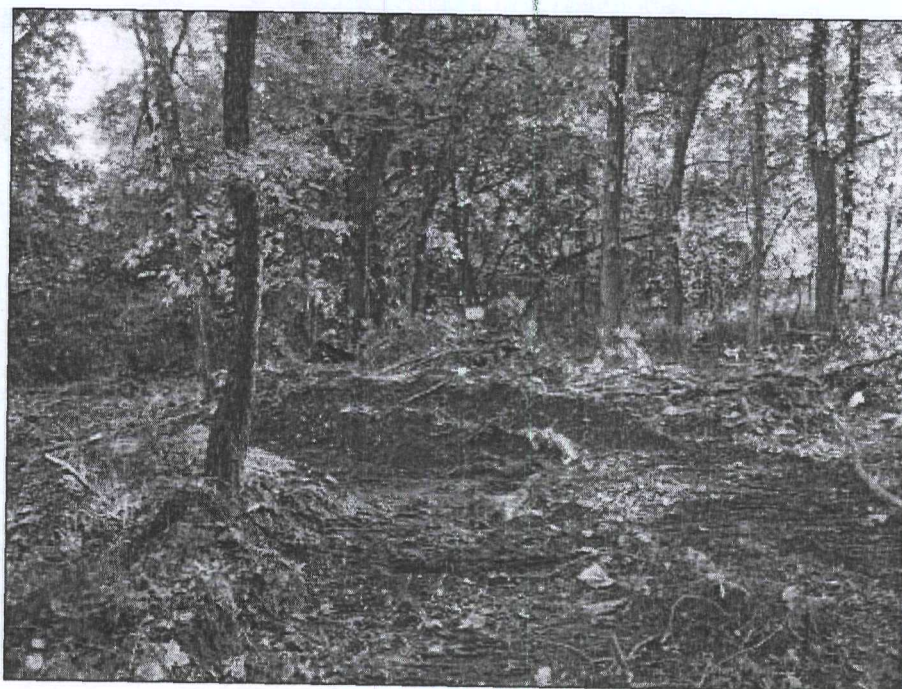
Picture 2: South-eastern corner of Site during grubbing (October 14, 2008)

Stabilization of the banks of the site bordering the wetlands began on Tuesday October 14, 2008. OSC, ERRS and RST 2 collected equipment from EPA Edison. A wheeled loader and a photocopier was delivered to Site. ERRS started grubbing in south-western corner of Site adjacent to Spicer Street perimeter fence. Approximately 5,000 ft² was cleared. RST 2 carried out particulate monitoring using DataRAM 4 particulate monitors - no particulate exceedances were recorded. Weather was fine, 70's°F, humidity 83%, wind 3mph, SW.

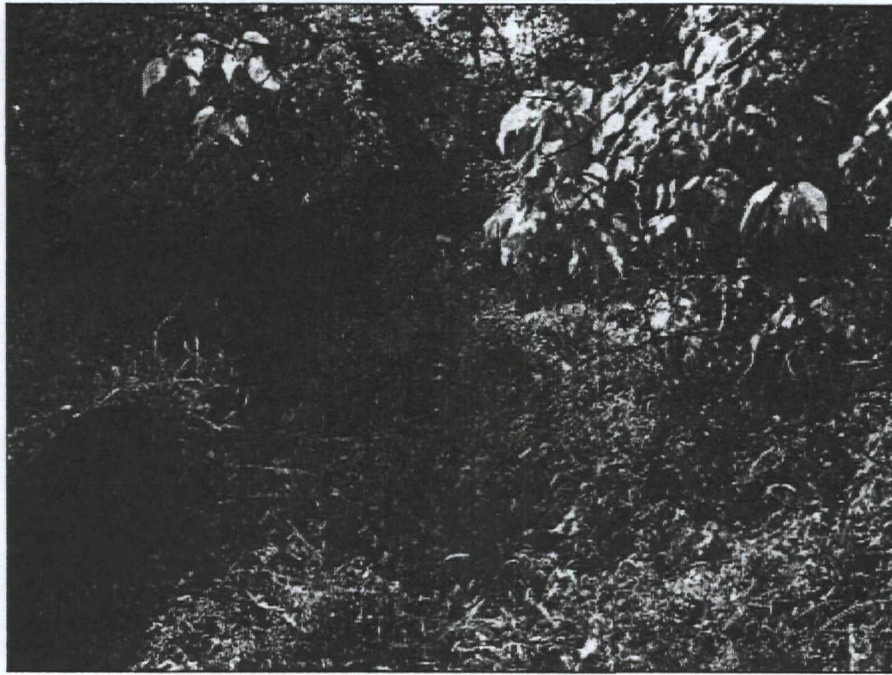
Picture 3: Slope bordering wetland at South-eastern corner of Site prior to grubbing (October 14, 2008)

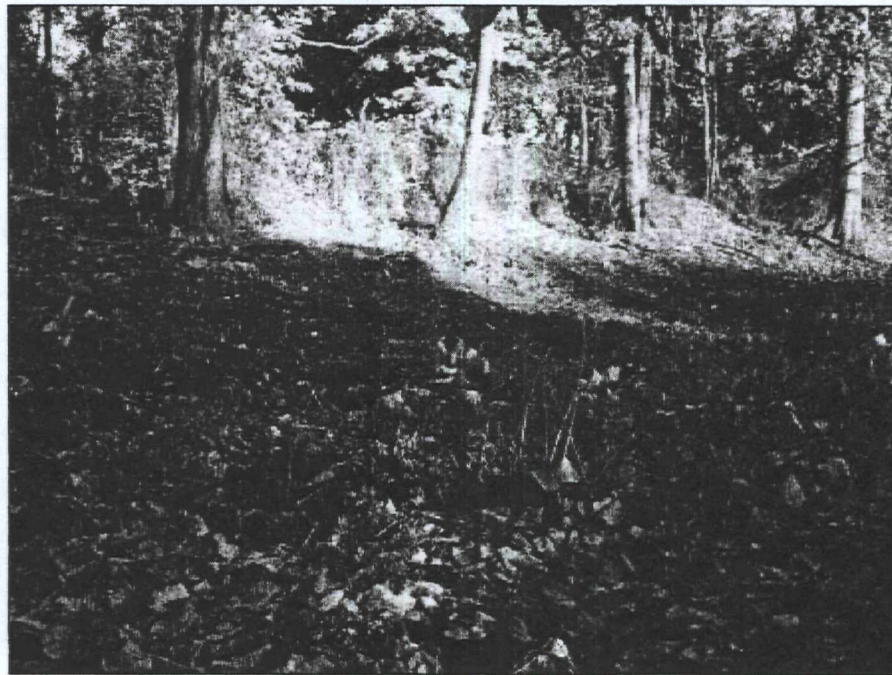
Picture 4: Slope bordering wetland at South-eastern corner of Site following grubbing (October 15, 2008)

10-15-08- ERRS installed the stone staging area. ERRS continued grubbing in South-western corner of Site adjacent to Spicer Street perimeter fence. Approximately 7,200 ft² has been cleared. ERRS installed geotextile material in South-western corner of Site. Approximately 750 ft² of geotextile material was installed. Verizon connected telephone service to Site trailers. OSC obtained replacement DataRAM from EPA, Edison. RST 2 carried out particulate monitoring using DataRAM 4 particulate monitors - no particulate exceedances were recorded. RST 2 measured total area cleared by ERRS. RST 2 photographed Site activities and generated photo documentation log. RST 2 generated daily site entry/exit log. RST 2 generated particulate monitoring summary. No particulate exceedances were observed. Weather was fine, 70's°F, average humidity 77%, wind 1mph, (calm).

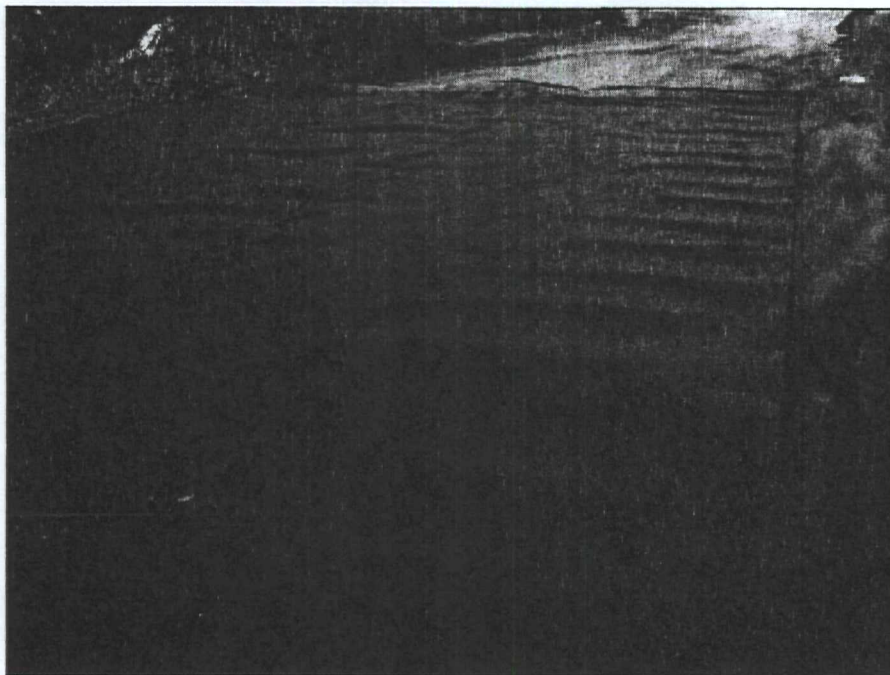
Picture 5: Poly sheeting placed over crushed stone base in Stone Staging Area (October 15, 2008)

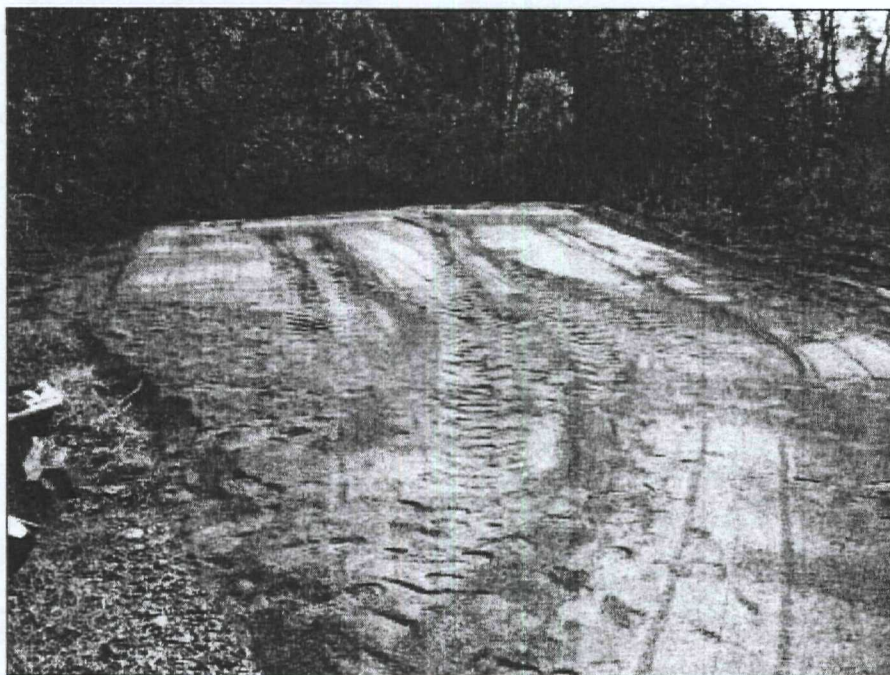
Picture 6: Additional crushed stone placed over poly sheeting in Stone Staging Area (October 15, 2008)

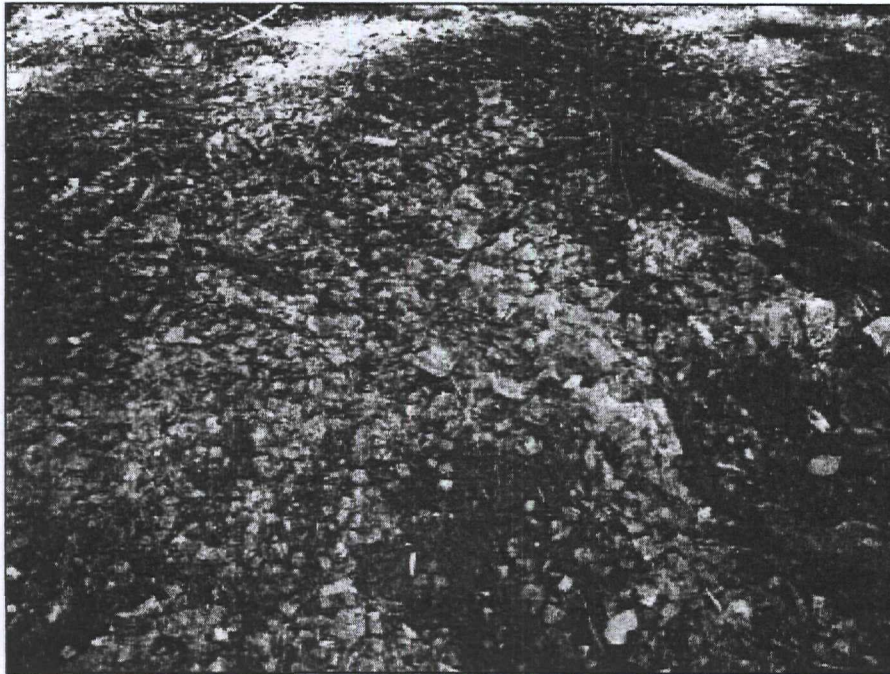
Picture 7: Capacitor film uncovered near Southwest corner of Site (October 15, 2008)

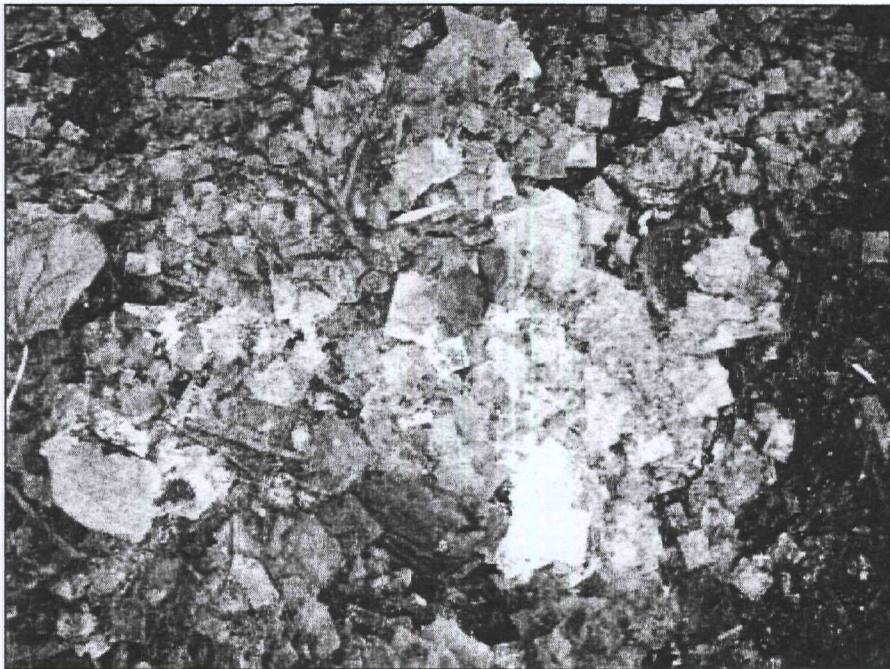
Picture 8: View from west along southern boundary of Site prior to the Removal Action
(October 15, 2008)

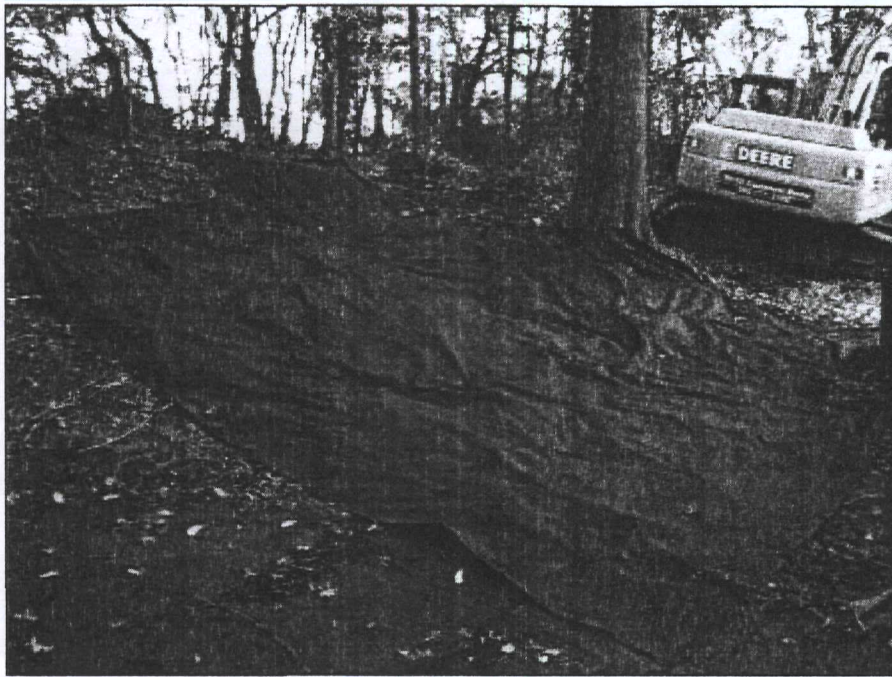
Picture 9: Geotextile material install on bank adjacent to wetland perimeter fence
(October 15, 2008)

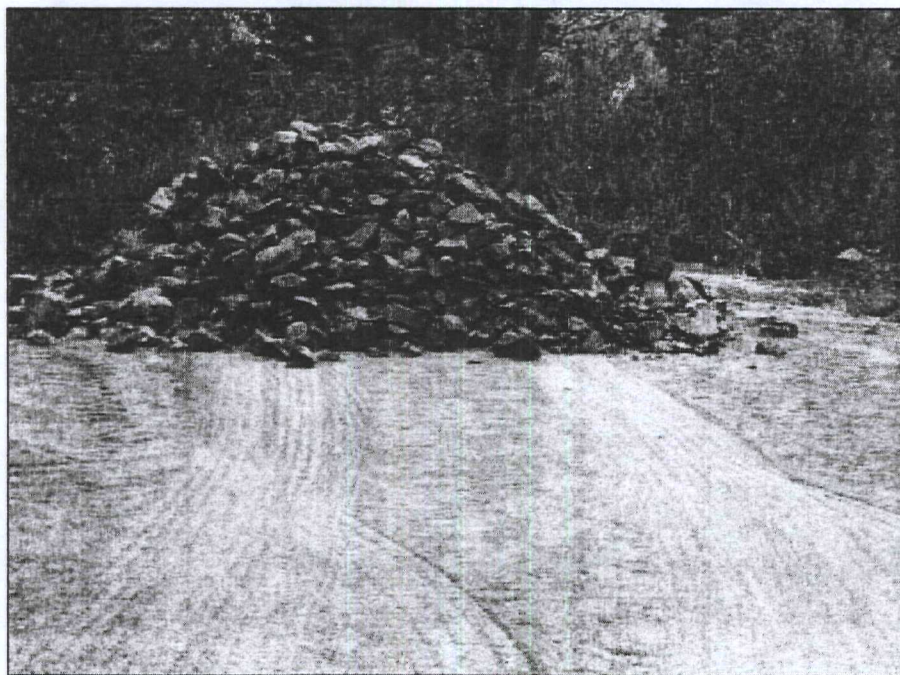
Picture 10: Rip-rap in staging area (October 16, 2008)

10-16-08- Six truck-loads of 6" D50 rip-rap were delivered to Site and staged. ERRS transferred staged stone to

prepared area in South-west corner of Site. ERRS installed stone over geotextile in South-west corner of Site. Approximately 3,000 ft² of geotextile and rip-rap has been installed. Electrician connected power to Site trailers. RST 2 carried out particulate monitoring using DataRAM 4 particulate monitors - no particulate exceedances were recorded. Particulate levels were elevated due to haze and high humidity. RST 2 photographed Site activities and generated photo documentation log. RST 2 generated daily site entry/exit log. RST 2 generated particulate monitoring summary. RST 2 generated particulate monitoring summary. No particulate exceedances were observed. Weather was cloudy, maximum temp. 79°F, average humidity 69%, wind 7mph, S-N.
